REPORT / SERVICE DETAILS

- **Project Name:** KOKAN RAILWAY Alternator staggering and winding
- **Location:** madgaon
- **Client Name :**

**Konkan Railway Corporation Limited.**
- **Project Start Date:** 10-sep-2024
- **Project Completion Date:** 10-oct-24
- **Status:** Completed

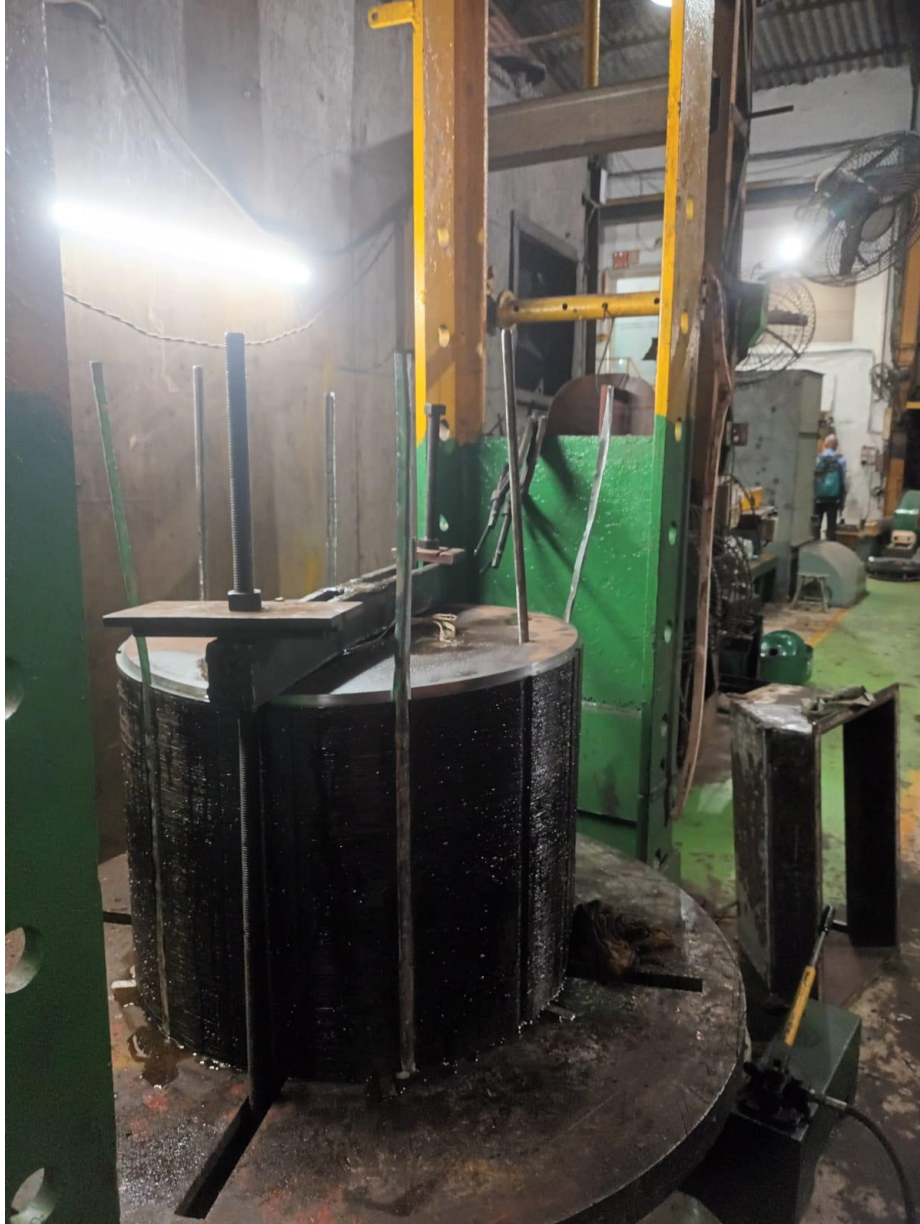
Photo

The project involved the complete dismantling of the **alternator** using a **hydraulic system** to ensure a safe and efficient disassembly process. Initially, the **cover was carefully removed from the stator**, followed by the extraction of the **core from the alternator body**. The next step involved **disassembling the core**, where each of the **1,365 plates** was individually removed with precision. Once separated, every plate underwent a thorough **cleaning process** to eliminate any accumulated dust, corrosion, or debris. Additionally, the **existing copper winding was removed** from the plates to prepare for rewinding. After the cleaning process, the plates were **rearranged and reassembled** systematically to restore the original core structure. Following this, the **winding process was carried out with high-quality copper**, ensuring optimal efficiency and durability. Finally, the **reassembly process was performed in reverse order**, carefully reinstalling the **core, stator, and alternator cover**, ensuring that every component was securely fitted and aligned for optimal performance.
